PREVENTIVE CONSERVATION
PRACTICE IN THE FIELD OF BUILT HERITAGE

PREVENTIVE CONSERVATION OF CHURCHES DURING TUNNEL WORKS IN STOCKHOLM

Henningson Anna

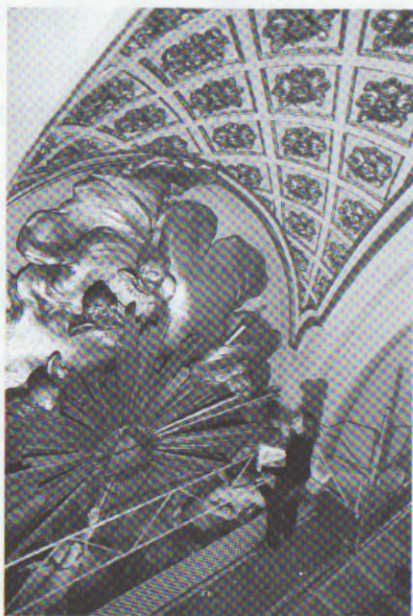
Fig. 6: Condition survey by mapping of the stucco altar in Maria Magdalena church. Photo: H. Ekestang
